V Fault Lines in the Kyotango City Area

Estimated Damages from an Earthquake caused by the Gomura Fault

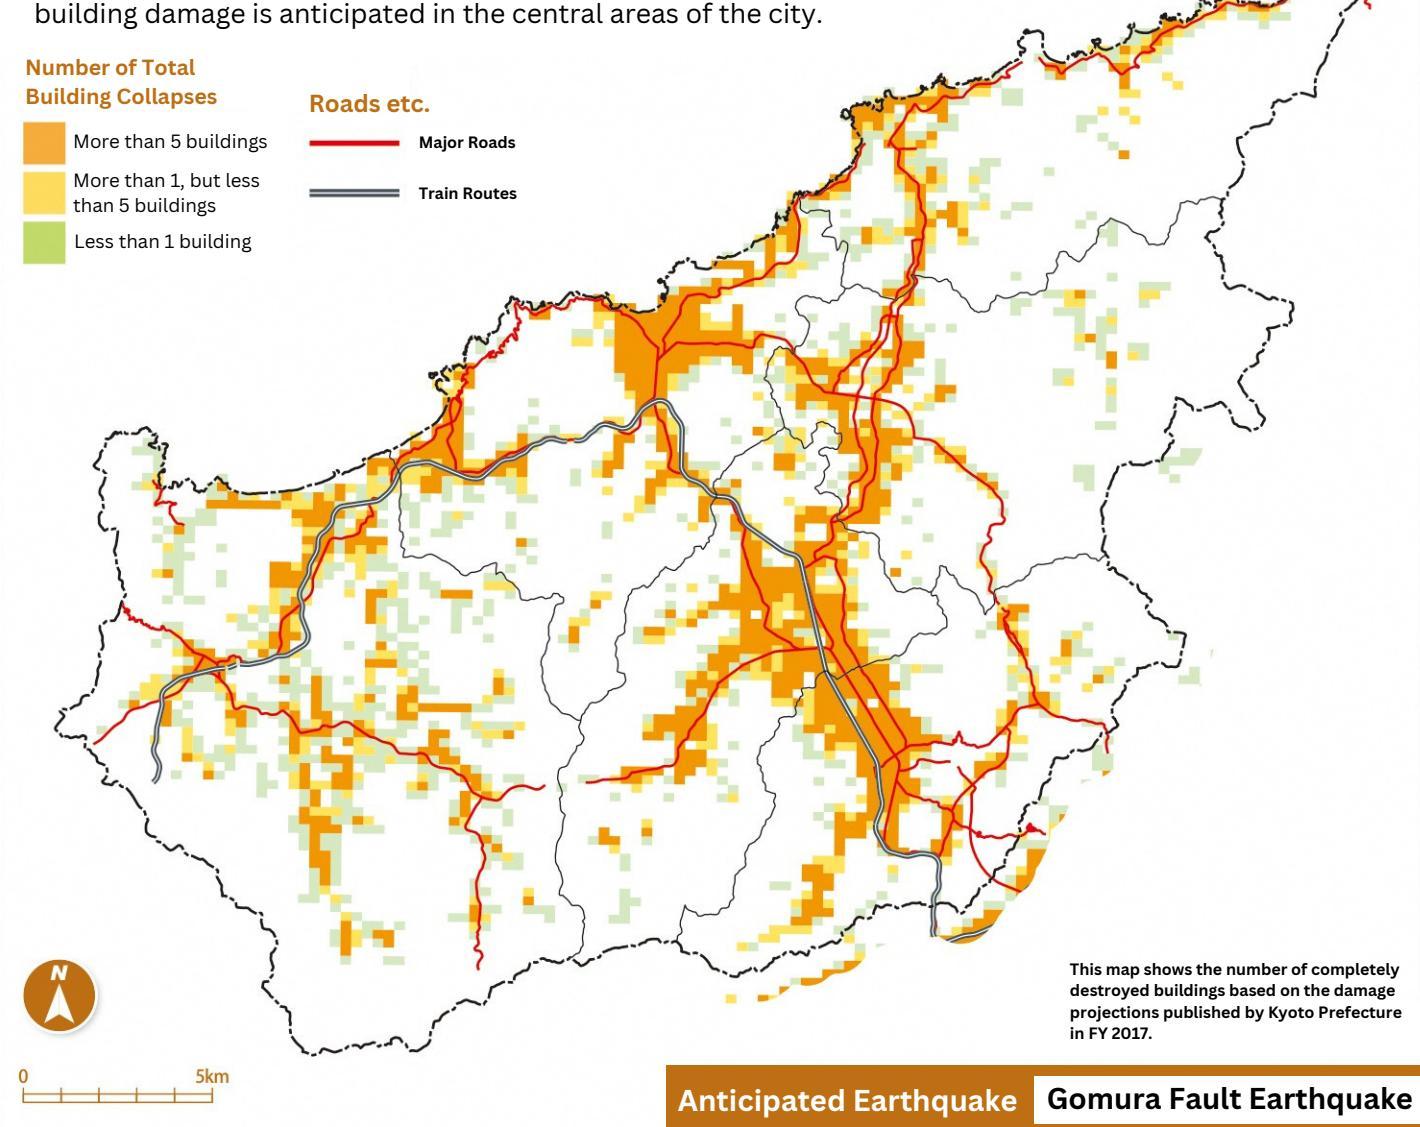
In the event of an earthquake on the Gomura Fault, severe building damage is anticipated in the central areas of the city.

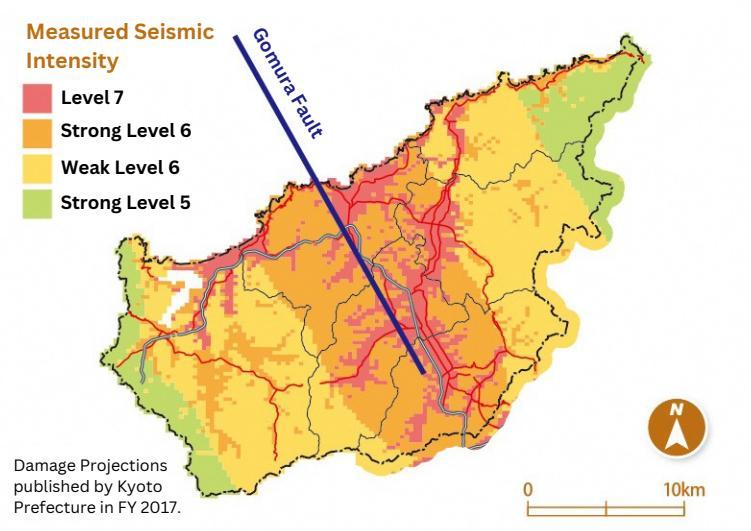
The Gomura Fault Line runs from north to south through our city. Following a level 7 earthquake (strongest level on the scale), a tsunami is expected to hit the area. Refer to the table on the right for estimated damages.

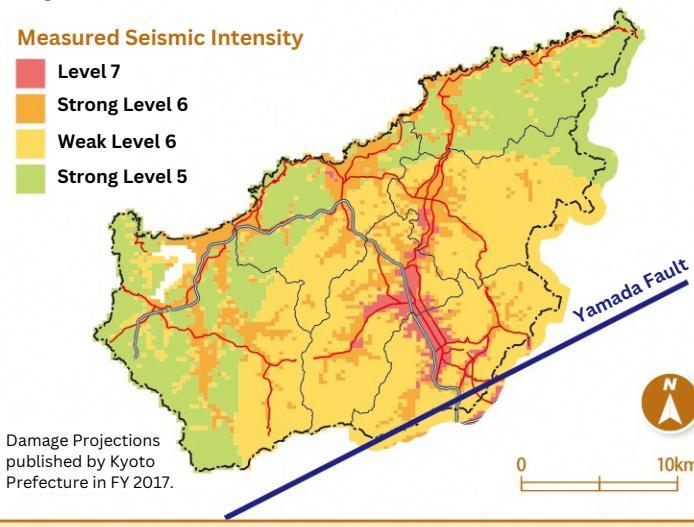
The Yamada Fault Line runs from east to west in the southern part of Kyotango City. For a level 7 earthquake, severe damages including 820 casualties, 27,120 completely-destroyed buildings, and 7,600 burned buildings are anticipated. Soil liquefaction is expected to happen in large areas.

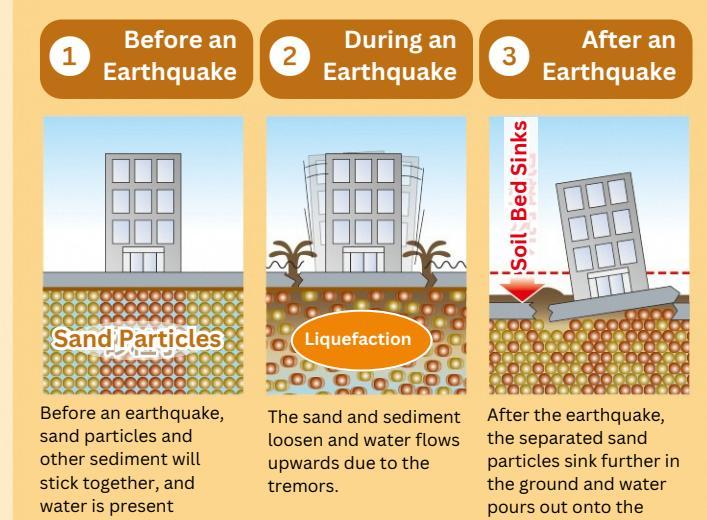
About Soil Liquefaction

When strong earthquakes occur, loosely-sedimented sandy soil and ground water at a high enough level will mix together momentarily and soften the soil into a liquid-like state. This phenomenon is called soil liquefaction.
